Certificate of Compliance
Inspection Form

New Subsurface Sewage
Treatment Systems (SSTS)

Property address: 4340 Lakeview Court

City of Orono Septic Asbuilt Form

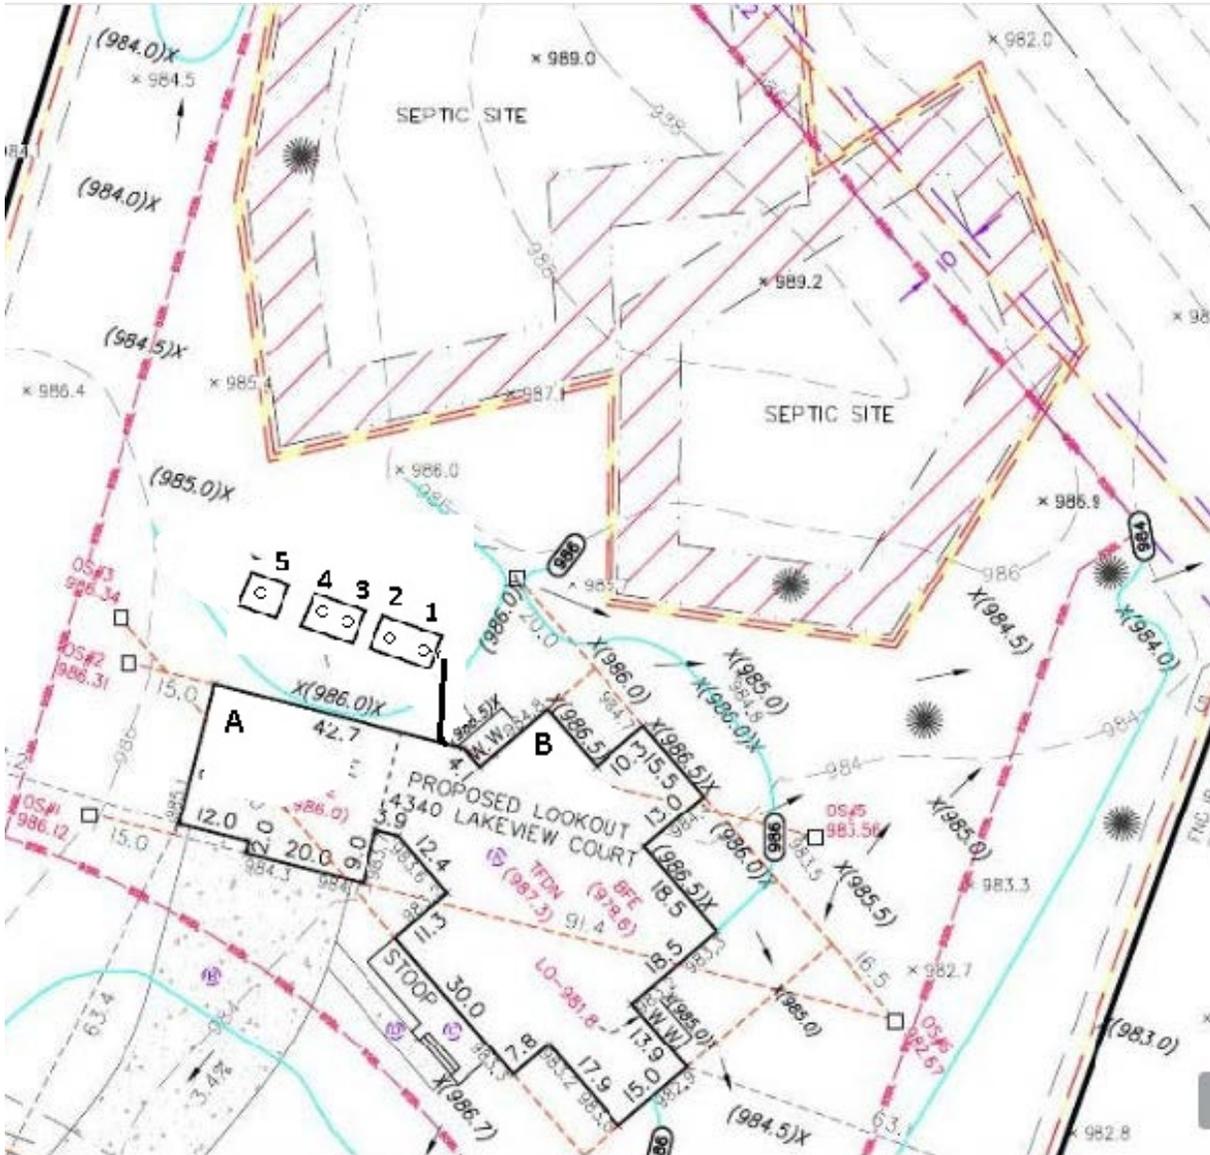
Address: 4340 Lakeview Court Building Use: SFD
 Installer: Knapp and Sons Setic LLC License # L2930 Date: 8/21/2019
 Septic Tanks: 1-2250 1-1000 Pump Tank: 1-1000 Date Finaled: 5/21/2020 Bedrooms # 5
 System Type: I II III Mound Trenches Pressure Bed Other _____

A	B
1	31'	35.5'
2	32'	43'
3	33.5'	48
4	36'	54'
5	42.5	64'
6		
7		
8		
9		
10		
11		
12
