Compliance inspection report form  
Existing Subsurface Sewage Treatment System (SSTS)

Parcel ID# or Sec/Twp/Range: 0711723220012 Reason for Inspection Property Transfer  
Local regulatory authority info: City of Orono  
Property address: 900 North Shore Drive W.  
Owner/representative: Vince Wigdahl Owner's phone: 651-755-6911  
Brief system description: Approximately 2-1300-gallon septic tanks, 1-1300-gallon lift station and 500 square feet of mound rock bed.

900 North Shore Dr. W.

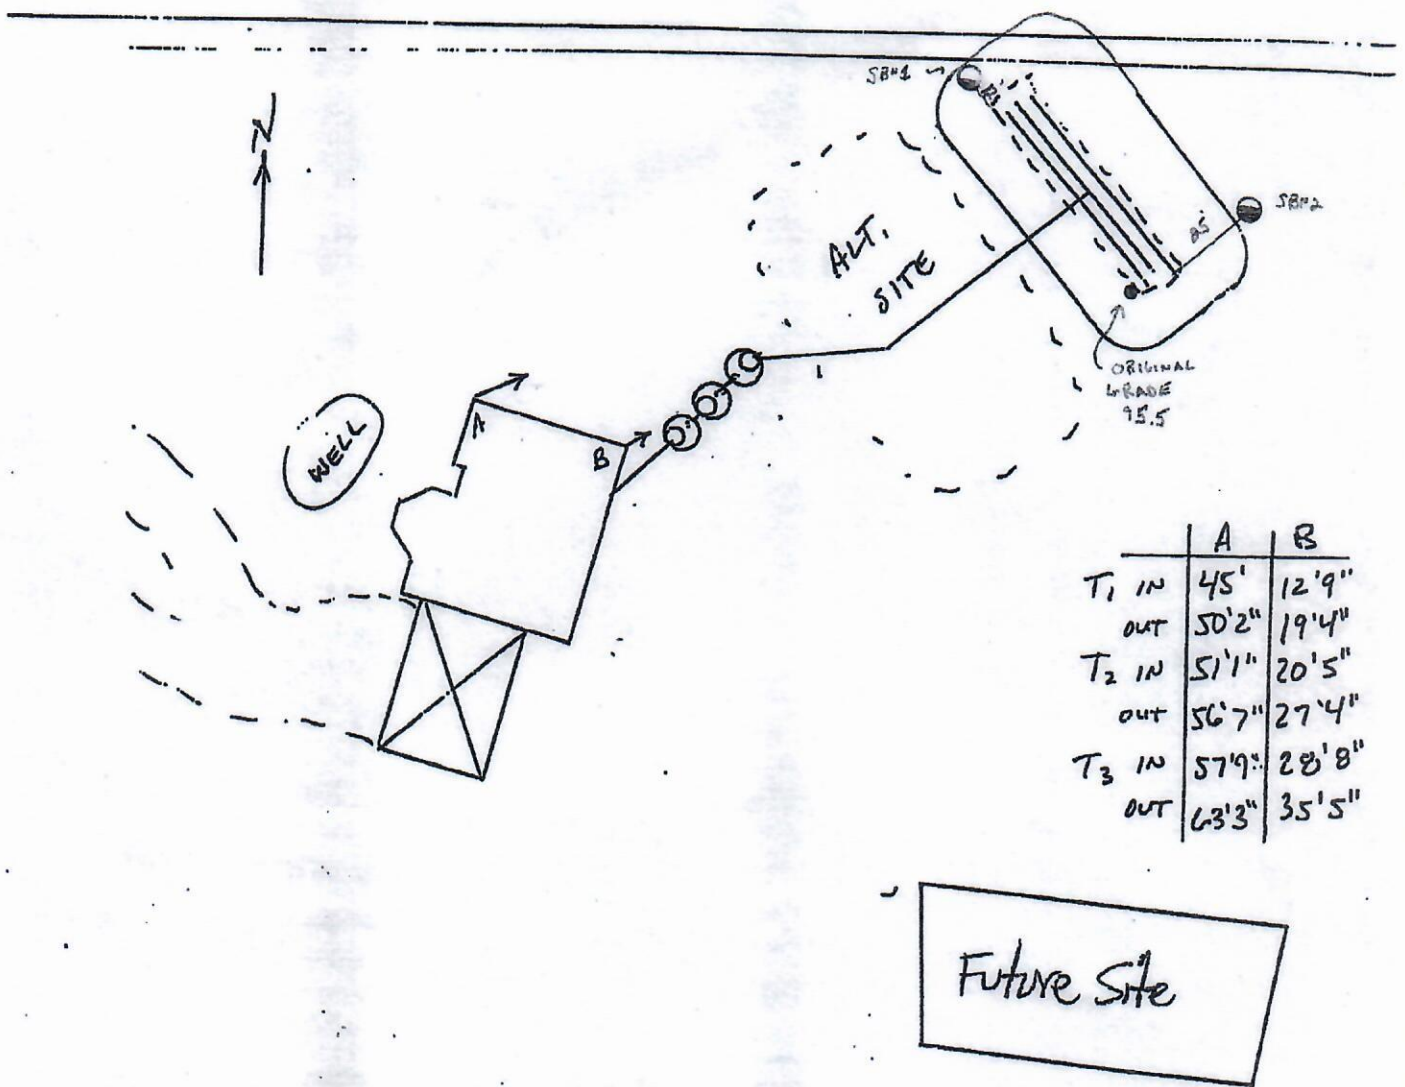
A	B
T <sub>1</sub> IN	45'	12'9"
OUT	50'2"	19'4"
T <sub>2</sub> IN	51'1"	20'5"
OUT	56'7"	27'4"
T <sub>3</sub> IN	57'9"	28'8"
OUT	63'3"	35'5"
